March 13th, 2017

**Limited Scope Fungal (Mold) Sampling & Physical/
Moisture Inspection Report**

**Lowcountry Apartments, #2F
71 Meandering Road
Spanish Moss, South Carolina 29000**

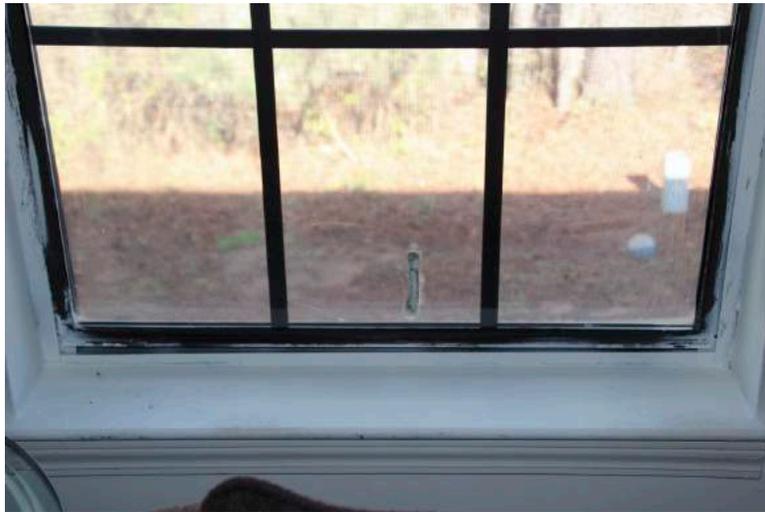
IMG_7542

Living Room, left window

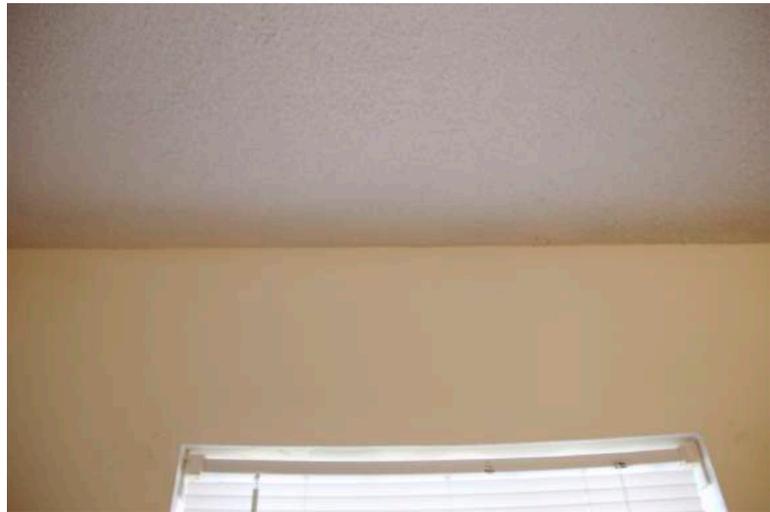
IMG_7544

daughter's bedroom ceiling

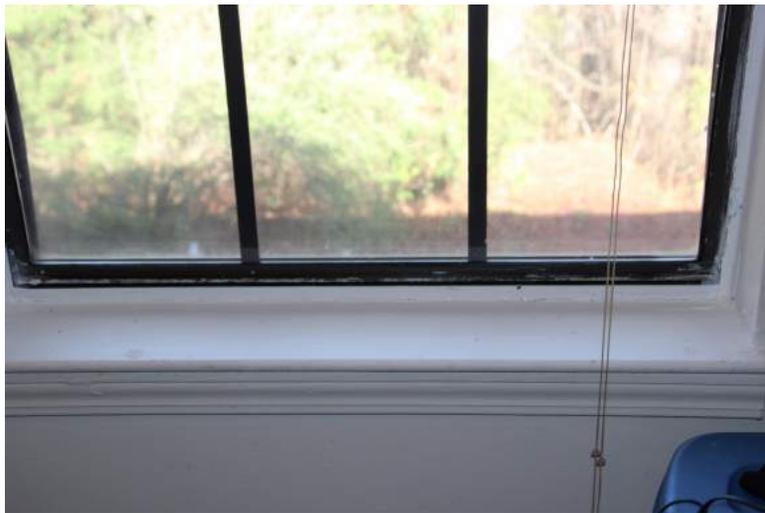
IMG_7546

Daughter's bedroom window

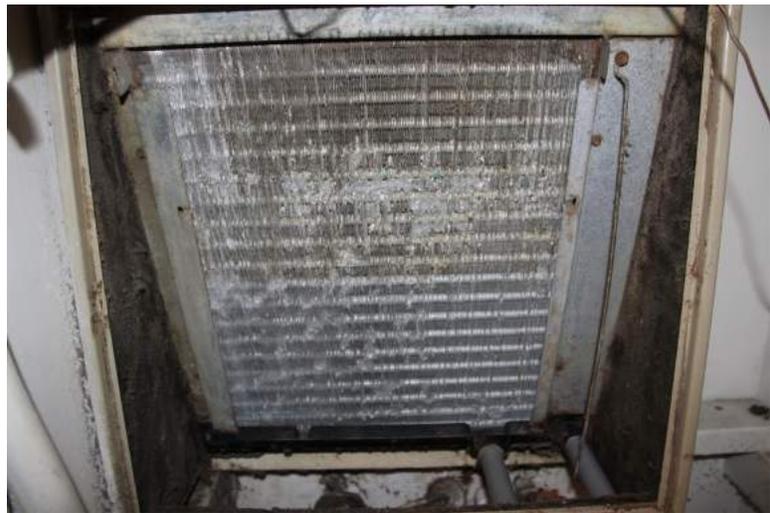
IMG_7547

Damaged AHU coil

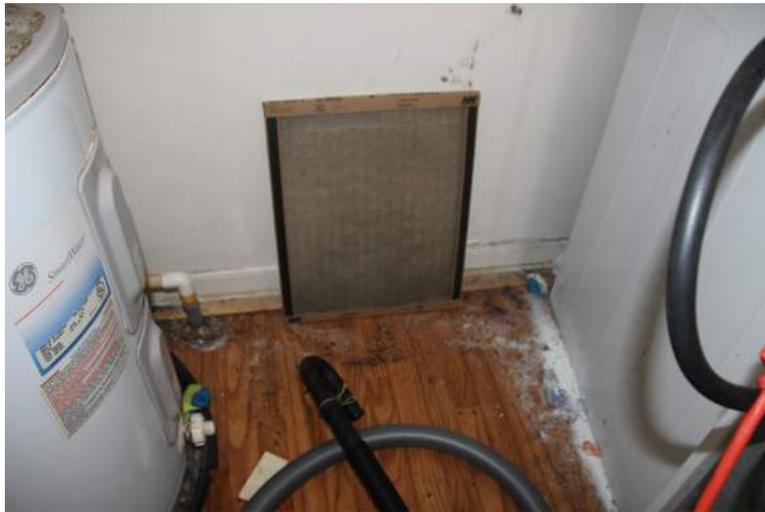
IMG_7549

Floor under washing machine

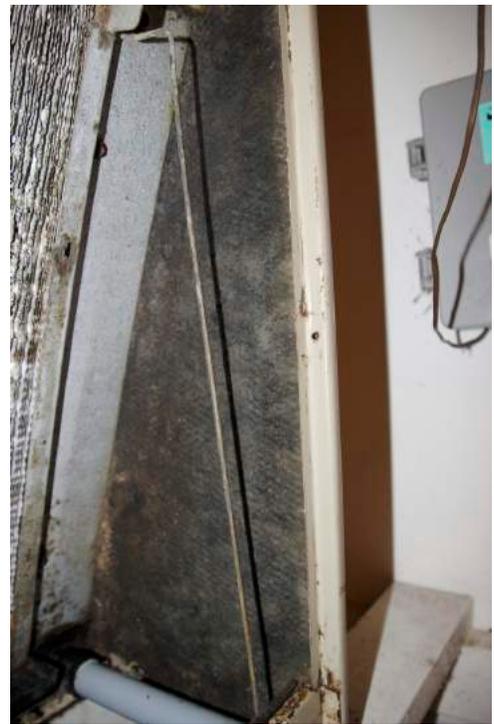
IMG_7552

Insulation after treatment

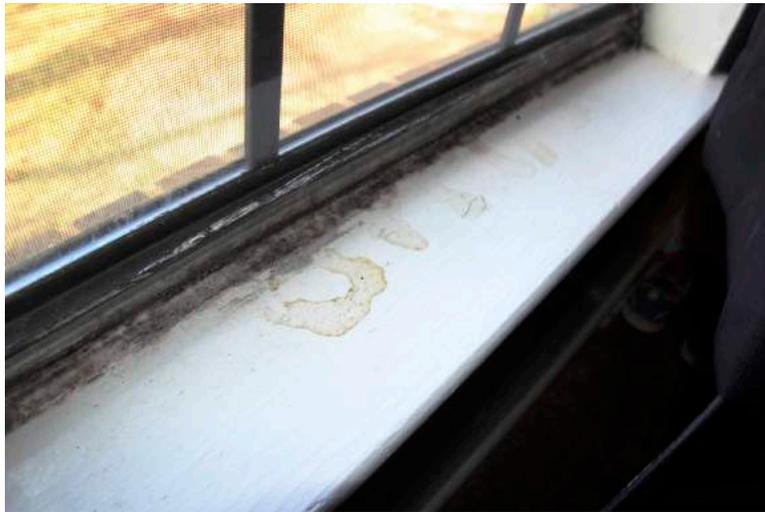
IMG_7558

The water staining on the master bedroom windowsill indicates that condensate is not being wiped by tenant. This has led to a recurrence of dark growth on sills and around the windows.

Master bedroom sill staining

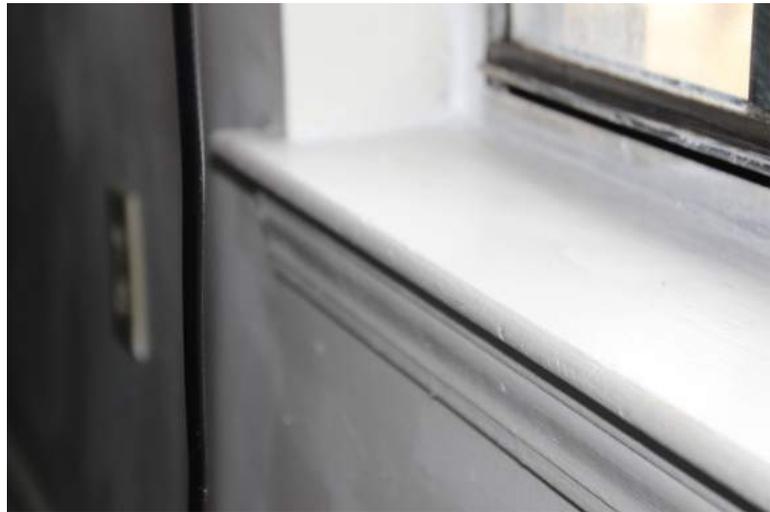
IMG_7562

Master bedroom window after treatment

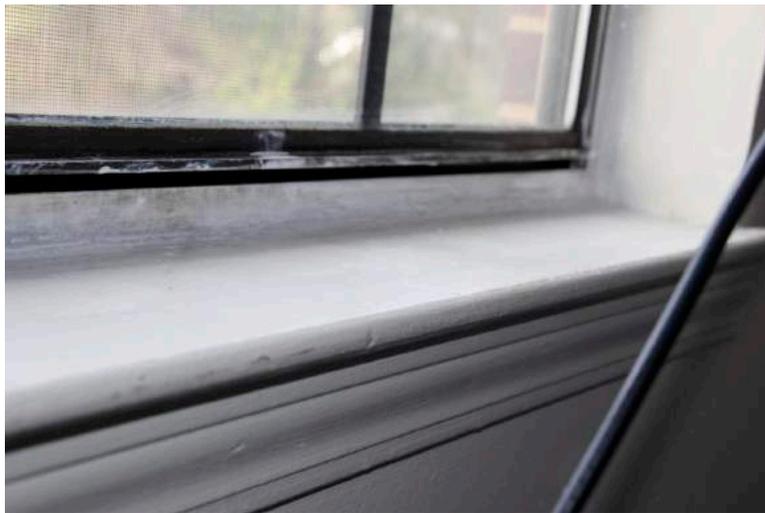
IMG_7565

Master bedroom window after treatment

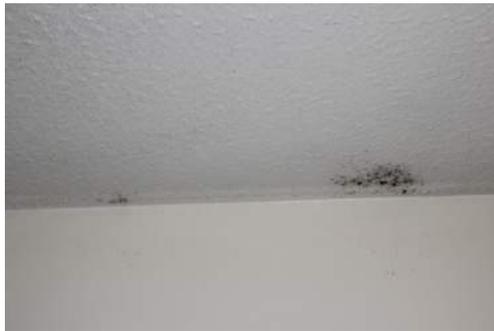
IMG_7511

A stain of 4-5 sq in above the window on the daughter’s bedroom ceiling had recurred (#7511) and was larger than in 2016 (#2785). Infrared camera (“IRC”) imaging with a FLIR B-CAM™ showed a temperature differential of 3.0-3.9° F. in that area. When a variation of 3.0° F.+ is present, it suggests that a hidden moisture reservoir caused by plumbing leakage or water infiltration could be occurring. The discolored areas were then checked with a Extech MO-290® handheld moisture

meters with a 2-prong attachment. The relative materials moisture in the discolored areas ranged from 11.4-12.4%; 6" from the discoloration the range was 10.1-10.3%.

7. The surface swab sample confirmed “Heavy” relative levels of *Cladosporium*. It is an allergen that requires higher than normal water activity.
8. IRC screening was positive for excess materials moisture on the ceiling area in the daughter’s bedroom. However, testing with the MO-290 was negative for excess moisture.

In the daughter’s bedroom it is likely that insulation is not spread thick enough above the area of fungal growth. This creates a direct interface between damp outdoor air and warm indoor air that fosters the growth confirmed by ESC. In the master bath

Discoloration on Daughter's BR ceiling

Scrape the popcorn ceiling where discolored. Clean and coat the areas of growth with sanitizer, growth retardant and stain blocker paint. Tenant MUST wipe accumulated condensate from windows and sills or growth will recur.

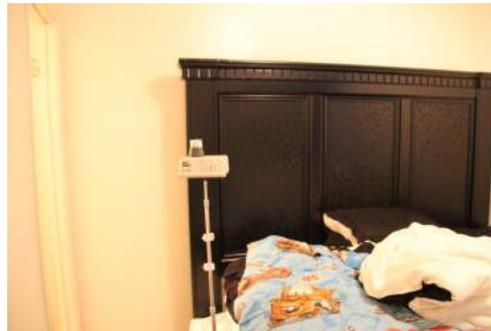
IMG_7514

3. *Chaetomium* was not trapped but *Stachybotrys chartarum* was in #MBR at a trace level of 13 s/M3. These are “water-loving” molds that can produce toxins. As well, one of the five spore types not in the baseline was *Ulocladium*, another “water-loving” mold. But, it is neither a toxin producer nor notable allergen.

The only slightly deficient sample result, *Stachybotrys chartarum*, is at a trace level. Water source is unknown. It must have 90%+ humidity for 8-20 days to germinate.

#MBR

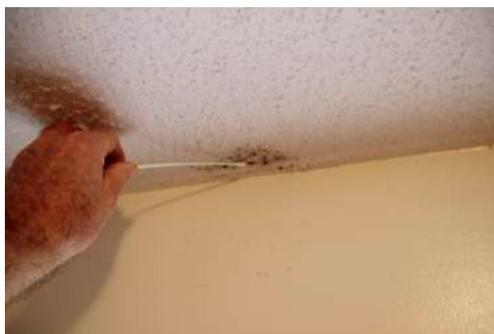
IMG_7516

A surface swab sample (**#2F-SW**) was collected from a discolored area on the ceiling of the daughter's bedroom (#7516). The swab was removed from a sealed, sterile packet and rolled over a 2 sq in area. It was then inserted into a sterile, self-locking tube with moistened cotton in its end to prevent detachment of particulates. The following table supplies its location & results:

Spore Type	Concentration
Cladosporium	Heavy

#SW-D

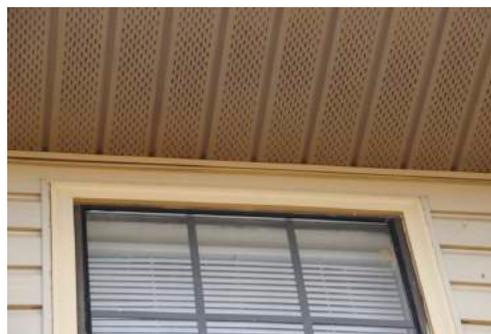
IMG_7517

Going outside, the vented soffit at this window was viewed (#7517). There were no gaps or staining seen. Roughly 18" right of the window the HVAC system's insulated refrigerant line enters the soffit (#7518 & 7519). There appears to be a small gap around that line.

Window/soffit, Daughter's BR

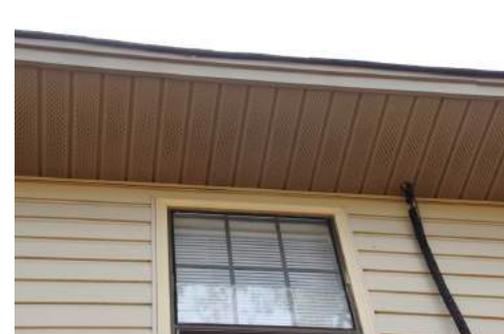
IMG_7518

With insulated refrigerant through soffit

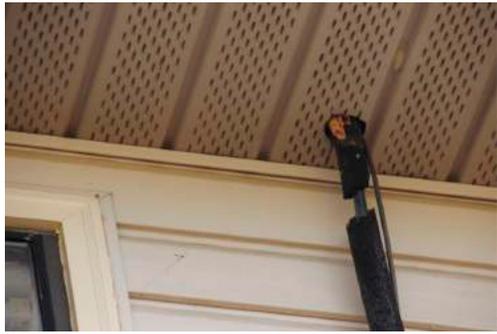
IMG_7519

Closeup of refrigerant line

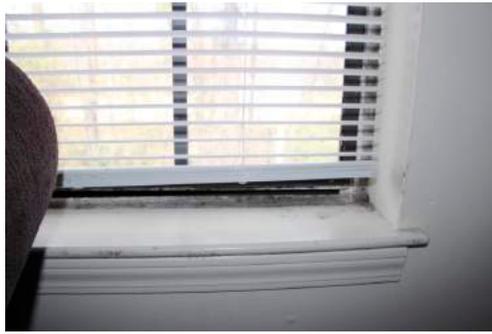
IMG_7520

As was the case in 2016, discoloration remains around all windows and on sills (Photos #7520, 7523, 7524, 7526, 7528 & 7530). In the Master BR a brownish water stain was present on its sill that was not present in 2016, and the chest of drawers has only been moved out around 6-8” more from the window.

9. There is still staining around windows and sills. In the master bedroom there is a brownish water stain that was not present in 2016.
10. Moderate particulate accumulation is present on insulation inside the AHU. Filtration used is a low efficiency element.

Right LR window

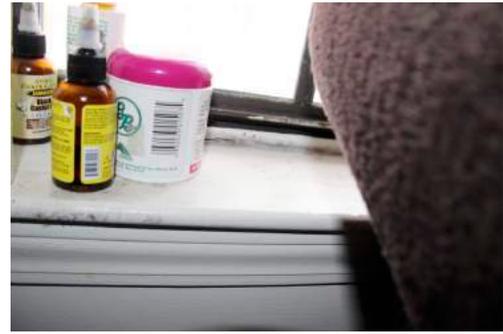
IMG_7523

Left LR window

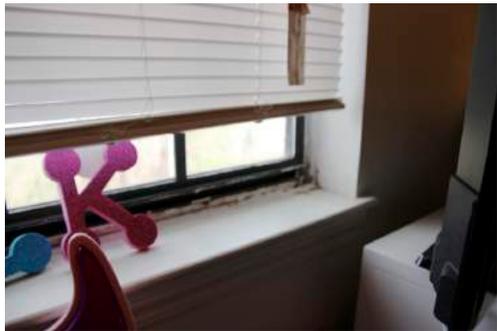
IMG_7524

Daughter's window

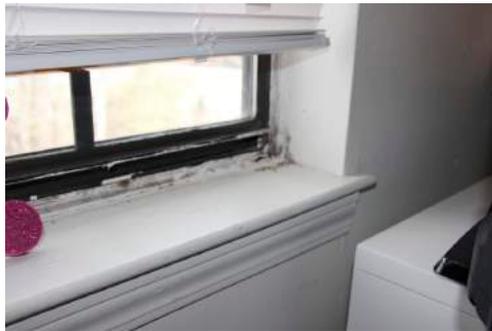
IMG_7526

Daughter's window

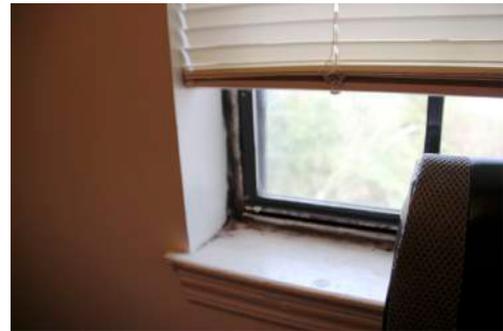
IMG_7528

Son's window

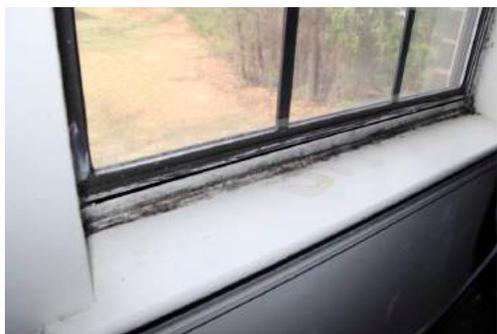
IMG_7530

Master BR window

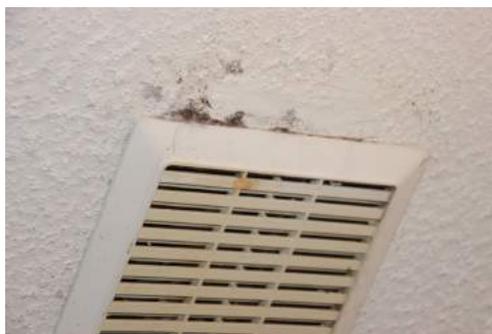
IMG_7533

There was also discoloration around the master bath's exhaust fan (#7533); its area was <2 sq in. In the hall bath water staining that was present next to the exhaust fan in 2016 remained (#7539).

tenant could not be operating the exhaust fan during shower use. However, both areas of growth are minuscule, and materials moisture levels are “normal” where staining is present.

Master Bath exhaust fan

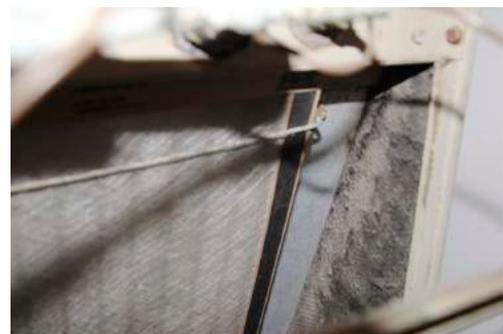
IMG_7535

The air-handling unit (AHU) was inspected last. It has moderate dust buildup on insulation (#7535 & 7536). Filtration is a MERV-5 rated woven fiberglass element. Underneath the AHU and beside the water heater there was significant dust accumulation (#7538).

Right side, AHU interior

HEPA vacuum the interior of the AHU and apply a growth retardant after cleaning with a sanitizer wipe. Fog the duct system for 5-6 minutes with sanitizer. Place a MERV-11 or 12 quality element in the AHU.

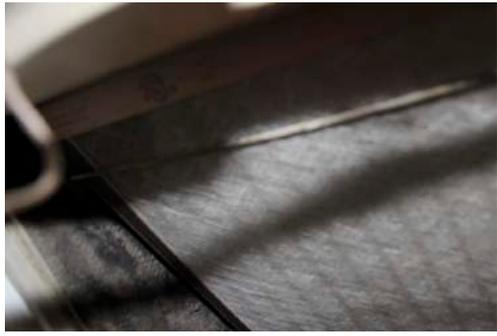
IMG_7536

Left side, AHU interior

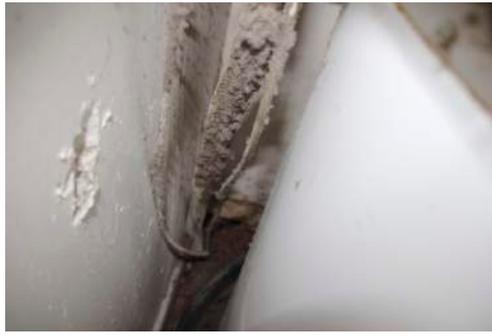
IMG_7538

Left of water heater under AHU

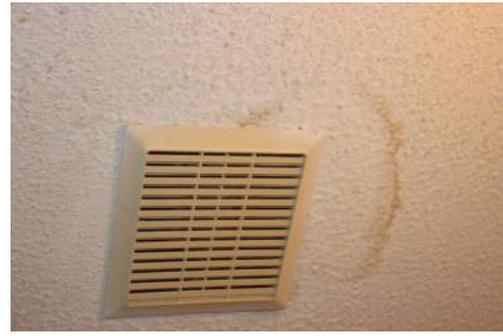
IMG_7539

Old staining in Hall Bath exhaust fan
